DSTO-TN-0086

A Review of Australian and New
Zealand Investigations on Aeronautical
Fatigue During the Period April 1995
to March 1997

Colin Martin

DEPARTMENT OF DEFENCE
DEFENCE SCIENCE AND TECHNOLOGY ORGANISATION

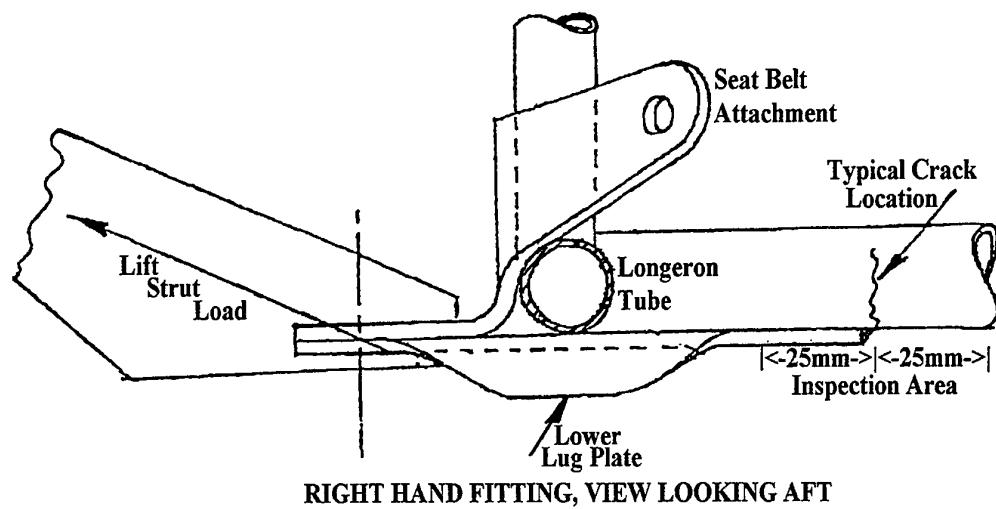
The Skyfox CA22 is an Australian development of the popular Kitfox amateur-built aircraft from the USA. One Skyfox was nearly lost when the carry-through for the wing struts, a steel tube, broke whilst the pilot was turning onto final approach. Fortunately the aircraft remained sufficiently intact to land safely.

The failure was caused by fatigue. Although the aircraft's design standard, JAR-VLA, suggested that the stresses were too low to cause fatigue, service experience has now proved otherwise. There were three main contributing factors, none of them unique: a discontinuity; a weld; and a severe load spectrum (flight training at low altitude). This example sounds a note of caution for the use of the threshold stress levels in JAR-VLA. Australian Skyfox aircraft must now be regularly inspected as shown in the diagram below:

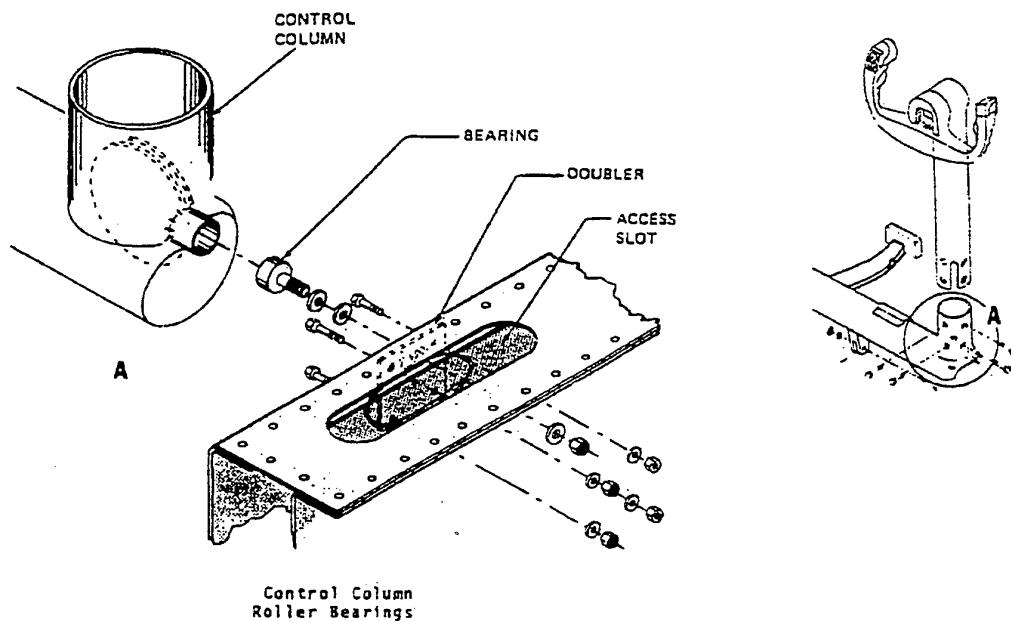
While teaching aerobatics, the instructor's control stick broke off at the base in the middle of a manoeuvre. Fortunately, the student was able to take control and land the aircraft safely. It was lucky that the front seat was not occupied by a non-flying passenger - or the forward control stick would not have been fitted!

The control stick, a steel tube, suffered from fatigue at a welded gusset - welds again! The control sticks in Australian aircraft must now be regularly inspected unless the aircraft is fitted with a new, stronger part.

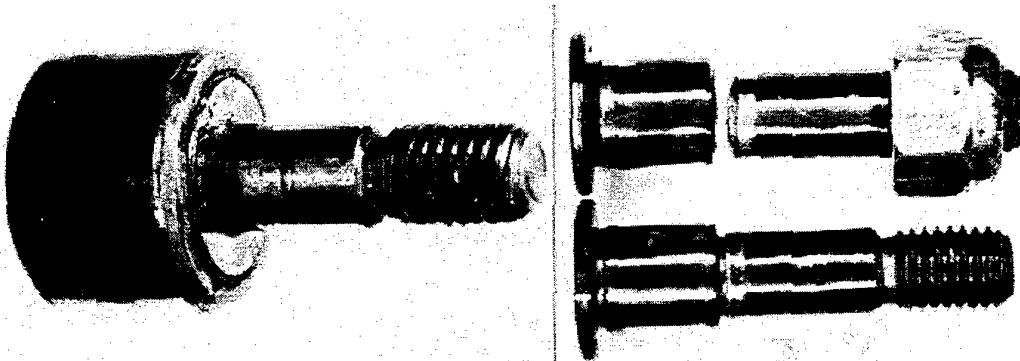
The control column failed at the pivot bearing. The shank of the pivot bearing failed as a classic case of reverse-bending fatigue after 15,000 hours of flight.

An intact pivot bearing, which appears to be a commercial cam follower qualified for the purpose.

Top: the broken pivot bearing.

The bearings in Australian SA 226 aircraft must now be replaced before 5,000 hours of flight.

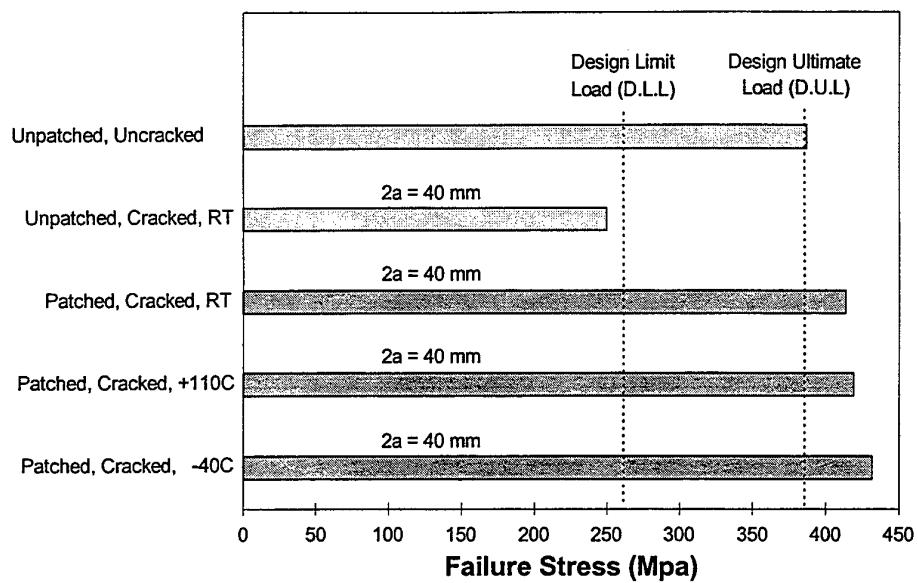
Figure 3. Residual Strength Test Results, F-111 Bonded Repair

A bonded composite repair to a critical fatigue crack in the lower wing skin of an RAAF F-111 aircraft has been fully substantiated. The crack was located in the lower wing skin at approximately 2/3 semi span (Figure 2). The crack had reduced the residual strength of the wing to below design limit load. The repair consisted of a 14 layer boron epoxy laminate patch which was bonded to the outer surface using FM-73 structural film adhesive. This is thought to be the most critical bonded repair yet undertaken anywhere in the world. The repair was designed and applied according to a RAAF document known as RAAF Standard Engineering C5033. A comprehensive substantiation program including testing of representative specimens and Finite Element Analysis was undertaken and has been successfully completed.

The Finite Element Analysis (Reference 19) included a calibrated three dimensional model which was subjected to structural and thermal loads. The analysis verified the adequacy of the original design which was performed using simplified equations based on 2-D lap joint theory. A comprehensive testing program (Reference 20) using representative cracked and patched specimens demonstrated the repair to be airworthy. The results of static load tests on representative specimens are shown in Figure 3. The tests show that the original crack had reduced the residual strength to below design limit, and that the repair restores static strength to design ultimate load capability, even at extremes of temperature. Spectrum loading tests were also performed on cracked and patched specimens. The crack continues to grow under the patch but the crack growth rate is reduced to an acceptable level as shown by the results for a range of patched and unpatched panels in Figure 4.

The results of this program have enabled the repaired aircraft to be returned to full operational status, and have given confidence in the design and application procedures for bonded repairs.
